INCREASING THE RESILIENCE OF HORTICULTURAL AND AGRICULTURAL SYSTEMS TO FUTURE FLOOD EVENTS IN THE HIGHLY PRODUCTIVE LAIDLEY CREEK VALLEY

J Walker¹, E Zavadil², R Hardie², H Ghajarnia²

¹ SEQ Catchments, Brisbane, QLD

² Alluvium Consulting, Melbourne, VIC

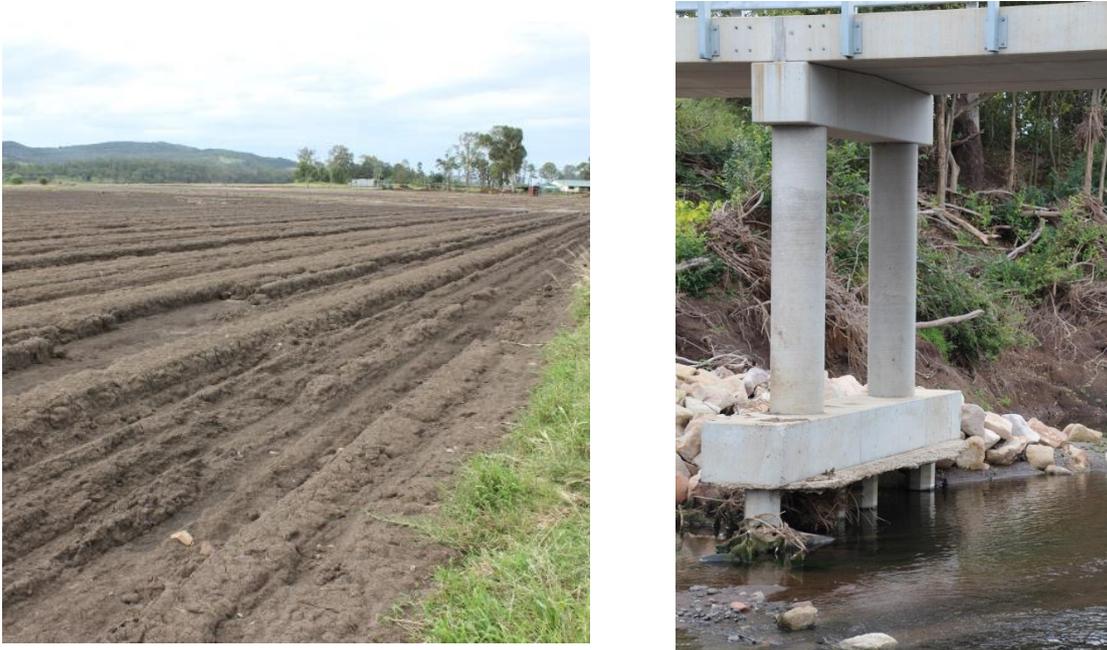
Figure 2: Damage sustained in the January 2013 flood of Laidley Valley (a) erosion of agricultural fields down to the controlled traffic line and, (b) undermining the foundations of bridge infrastructure caused by deepening of the Laidley Creek.

The January 2013 flood had significant immediate and ongoing impacts to infrastructure and agricultural production in Laidley Valley (Figure 2). Flood water inundated a significant portion of the floodplain within the project reach (Figure 3), resulting in crop loss, extensive damage to farm equipment and substantial areas of floodplain erosion and sediment accretion. Floodplain scour was most severe in areas of channelized flow, which in numerous locations was aggravated by levee breaches

(due to the creek bank eroding from beneath the levees), resulting in large, uncontrolled pulses of flood waters breaking out across the floodplain. Areas which were recently cultivated, fallow, or had minimal cover such as immature crops, sustained the most acute topsoil erosion.

Topsoil erosion, up to 45 cm in depth (down to the controlled traffic line), was experienced across a number of production fields and downstream sediment deposition of up to 100 cm depth occurred over a number of fields. In addition to affecting the physical form of the field (drainage, level and bed form), the soil nutrient balance and physical properties (such as texture) were also impacted. A permanent loss of productive land also occurred as a result of stream bank erosion, with lateral erosion of up to 20 m experienced on some meanders (Figure 4). Anecdotally, producers in this 15 km stretch of floodplain spent in excess of \$1M in immediate recovery efforts, and substantial further costs associated with capital value of lost land, equipment replacement and ongoing lost production. Some fields have not returned to production more than one year after the event.

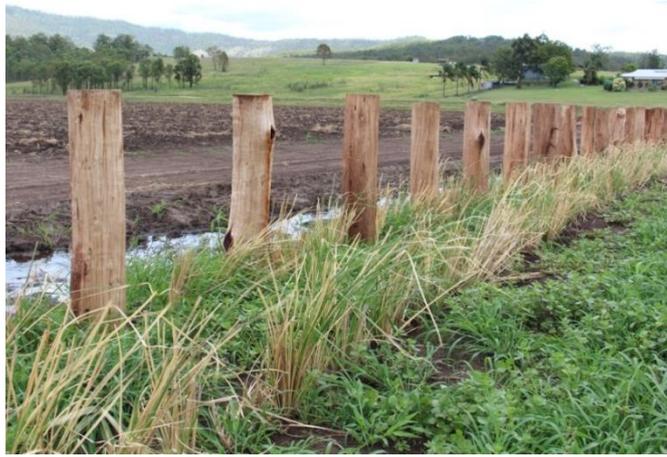
Figure 5: Cross floodplain roughness structure positioned perpendicular to the direction of flow. (a) Design of cross floodplain roughness structure composed of row of hardwood posts and vetiver (*Chrysopogon zizanioides*) hedge. Image shows recently planted vetiver, with expected height of mature vetiver, to be around 1 m, and (b) Structure creates a backwater zone behind the structure.

Innovative cross floodplain roughness structures, composed of pole and vetiver hedges (Figure 5), were conceived as a means to increase cross floodplain roughness at strategic locations on the floodplain. These structures were built into the 2D hydraulic model as semi-impervious barriers, of 50% porosity, with a manning's n value of 0.15. Results indicate a significant reduction in shear stress extending 100 m to 200 m upstream of the structures as a result of a backwater zone being created upstream of the hedge (Figure 6). This will decrease the risk of scour and encourages sedimentation in the backwater zone. In addition, the structures are expected to laterally spread the flood water behind the hedge, thereby reducing the concentration of flow in the lowest lying areas and potentially reduce scour on the downstream side of the hedge. Seven structures were modelled at various locations on the Laidley Creek floodplain, with a prioritization of these structures being made based on the magnitude and extent of their reduction to potential scour.

The roughness structures are most suited to locations which have a high risk of floodplain flood flows and where they are able to be placed perpendicular to the expected direction of flood flow and in production systems that face a greater risk of topsoil erosion, for example intensive vegetable production. The relative narrowness (approximately 2-3 m) of these structures ensures only minimal forfeiture of land from production. Two of these structures have been installed at key locations on the Laidley Creek floodplain.
