# DARWIN FLASH FLOODING – IS A LEVEE THE SOLUTION?

**J Wall<sup>1</sup>, P Saunders<sup>2</sup>, S Ruscheinsky<sup>1</sup>**

<sup>1</sup>Jacobs Sinclair Knight Merz, Sydney, NSW

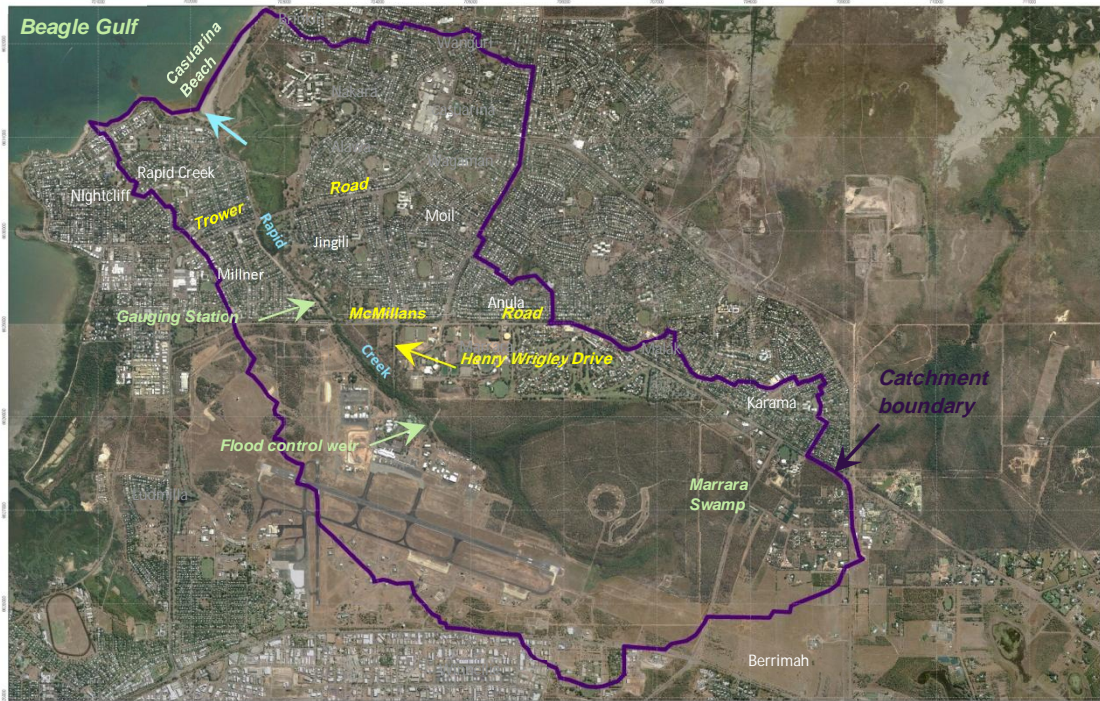
**Figure 1 Rapid Creek Catchment and Features**

Rapid Creek rises in the Marrara Swamp at the eastern end of Darwin Airport, and flows for 9.8 km discharging into the sea (Beagle Gulf) at the southern end of Casuarina Beach (Refer **Figure 1**). The Rapid Creek catchment covers an area of 28 sq. km and includes parts of the suburbs of Karama, Malak, Anula, Moil, Jingili, Wagaman, Alawa, Casuarina, Wanguri, Nakara and Brinkin, Millner and Rapid Creek.

The Marrara Swamp is drained by two separate drainage lines, on the north western and south western sides of the Swamp. Where the two drainage lines re-join to form Rapid Creek, a Flood Control Weir exists which attenuates the peak discharge and delays the floodwaters. The Flood Control Weir was constructed in 1985.

Road crossings of Rapid Creek can be found at Henry Wrigley Drive, McMillans Road (where the crossing is known as Kimmorley Bridge), and Trower Road.

A stream gauging station has operated continuously at Rapid Creek since the 1960s. It is located at the upper end of the Freshwater Gardens.

There have been a number of studies into flooding along Rapid Creek since the establishment of the Darwin Northern suburbs. In the late 1990s, a study by Connell Wagner [May 1999] produced floodplain mapping of the area between Trower Road and McMillans Road for the Department of Lands and Planning. A number of properties were identified as being at risk. A major flood occurred in February 2011 during the formation of Cyclone Carlos over Darwin. A number of properties were inundated and floodwater was understood to have entered houses in the suburb of Millner (refer to **Figure 1** for location).

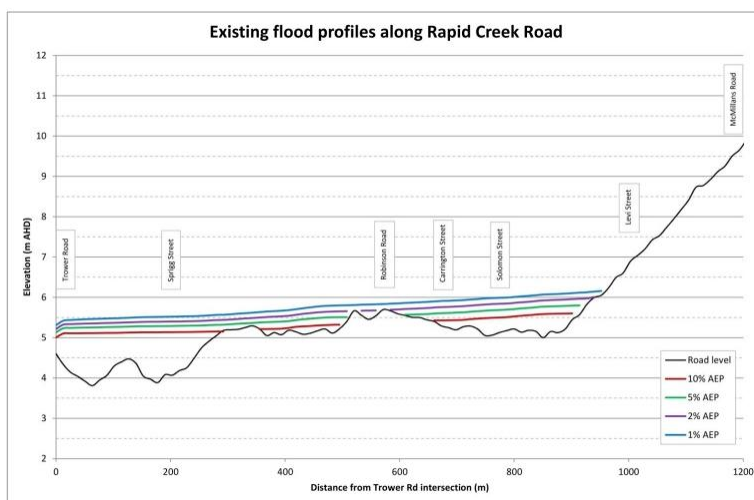
**Figure 3 Design flood profiles along Rapid Creek Road**

A levee along Rapid Creek Road to prevent inundation of properties in Millner was considered. To determine appropriate heights of a levee the existing design flood profiles along Rapid Creek Road were plotted and are shown in **Figure 3**. To provide protection for the 1% AEP (Q100) event with an appropriate freeboard, a levee along Rapid Creek Road would need to be up to 2.0m high near the intersection with Trower Road.

A levee option to provide protection for the 1% AEP (Q100) flood event was assessed in the TUFLOW hydraulic model. The levee would commence near Levi Street and would extend along Rapid Creek Road for approximately 1.1km. The average height of the levee would be about 1.5m.

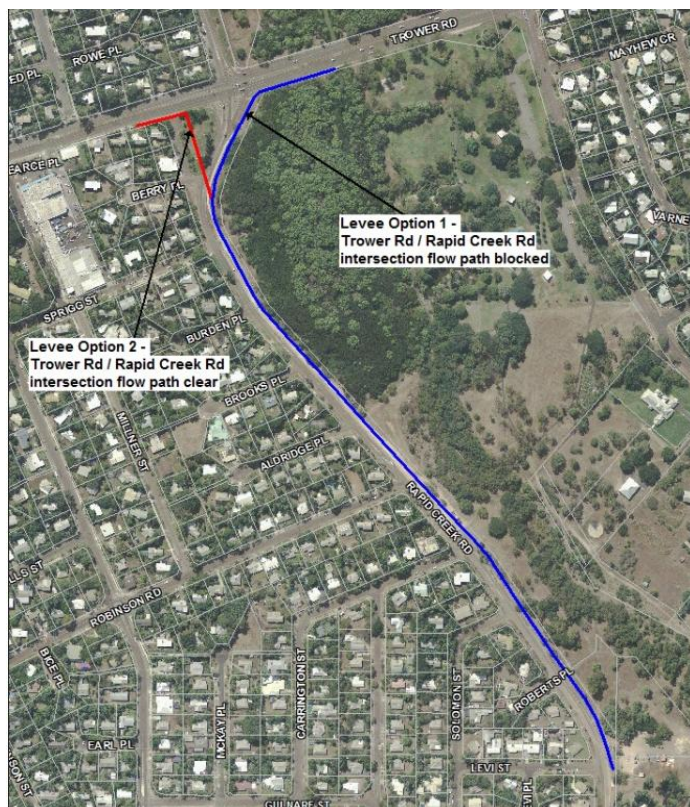
**Figure 4 Levee alignment options**

Two alignments of the levee near the Trower Road intersection were tested as shown in **Figure 4**:

- Levee Option 1 – levee continues east along Trower Road until the bridge, thereby obstructing the existing flow path over the intersection.
- Levee Option 2 – the levee alignment was selected so the existing flow path remains clear. Modifications to the intersection are required to accommodate this option.

The relative change in 1% AEP flood levels as a result of Option 1 was appreciable (greater than 300mm) so was not considered viable. Option 2, however, had a relatively minor impact on flood levels, with a maximum increase of 80mm, and could be considered viable in relation to flood impact.

The hydraulic model showed that introduction of a levee would increase flood levels in the main channel and right bank. Levee Option 1 was found to increase flood levels by 300mm at Trower Road with the impact extending to just upstream of Levi Street near the Gauging Station. Blockage of the Rapid Creek Road/Trower Road intersection flow path (Option 1) would cause more flow to be diverted to the right (east) bank of the Creek and this would cause new areas to be inundated near the intersection of Trower Road and Freshwater Road. For Levee Option 2, the increase in flood levels is only 80mm and the effect will not extend as far upstream.
